Starship Orbital Test Flight 1 Final Mishap Investigation Report

Date: 08/21/23

Written by: Shana Diez

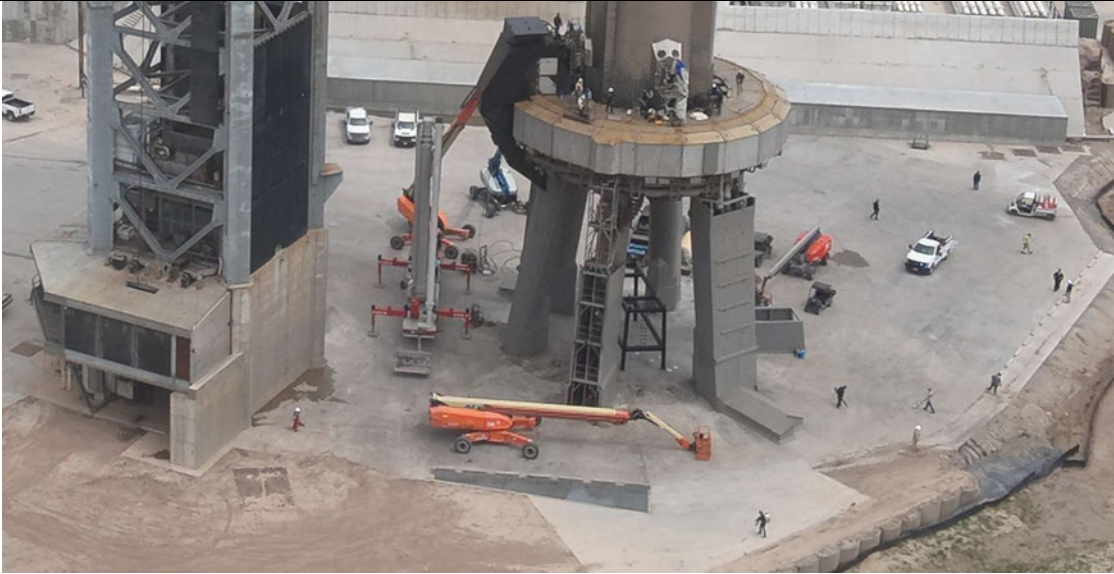
Shortly after liftoff, video evidence indicates that a significant structural failure of the launch pad deck foundation occurred. This failure resulted in bulk soil displacement below and around the launch mount sending a considerable amount of sand and debris into the air. (b) (3) (A)

One of the more visible additional observations associated with OTF-1 was the damage to the pad deck under the launch mount (b) (3) (A), (b) (4)

As a result of lessons learned for Starship OTF-1, SpaceX has redesigned the pad deck and foundation (b) (3) (A)
