**IN THE UNITED STATES DISTRICT COURT  
FOR THE DISTRICT OF MARYLAND**

**GRACE OCEAN PRIVATE LIMITED,  
as Owner of the M/V DALI,**

**Civil Action No. 1:24-cv-00941**

**UNITED STATES' CLAIM AND ANSWER TO PETITIONERS  
GRACE OCEAN PRIVATE LIMITED AND SYNERGY MARINE PTE LTD'S  
PETITION FOR EXONERATION FROM OR LIMITATION OF LIABILITY**

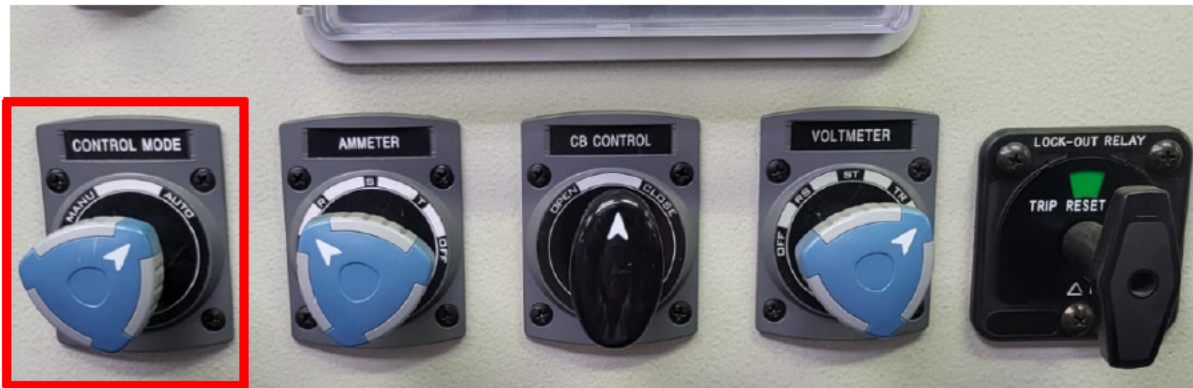
68. When in the automatic mode, if there is a loss of power through one of the step-down transformers, then the electrical system automatically transfers power to the other step-down transformer. Automatic transfer does not require crew intervention and results in the restoration of electrical power to the ship in a small number of seconds.

69. In contrast, when in manual mode, if there is a loss of power through one of the step-down transformers, the DALI's crew must manually transfer electrical power to the other step-down transformer—while in the darkness of a power outage.

*Step-down transformer controls, with the Auto/Manual Control Mode selector at far left. This photograph was taken post-accident.*

107. The inexplicable failure to use the “automatic” control mode on the step-down transformers rendered the DALI unseaworthy under the circumstances and was caused by Petitioners’ mismanagement of the ship and failure to properly instruct or train the crew. *See, e.g., In re Hercules Carriers, Inc.*, 566 F. Supp. 962, 976 (M.D. Fla. 1983) (“A shipowner has a non-delegable duty to provide a competent master and crew and to insure that its vessel is seaworthy so that any loss occurring by reason of fault or neglect in these particulars is within the privity and knowledge of the shipowner.”).

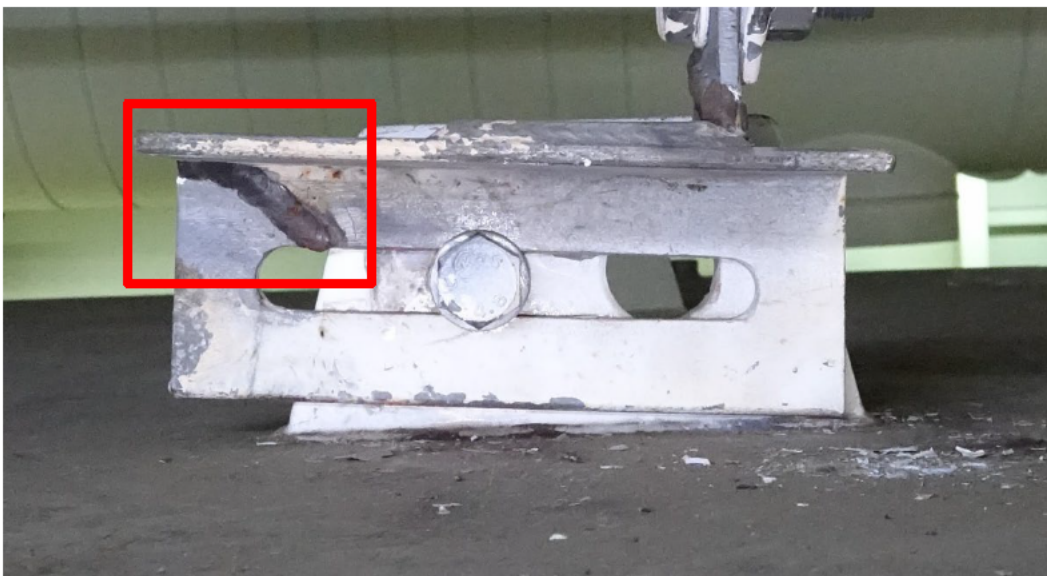
73. Excessive vibrations caused multiple cracks to form in one of the braces to the number 1 step-down transformer, including in the steel bracket between it and the top of the transformer.

*Cracked steel bracket with weld repair at the number 1 step-down transformer.*

74. Rather than address the underlying vibration problem, or even replace the cracked component, Petitioners simply welded over the cracks and carried on with business as usual.

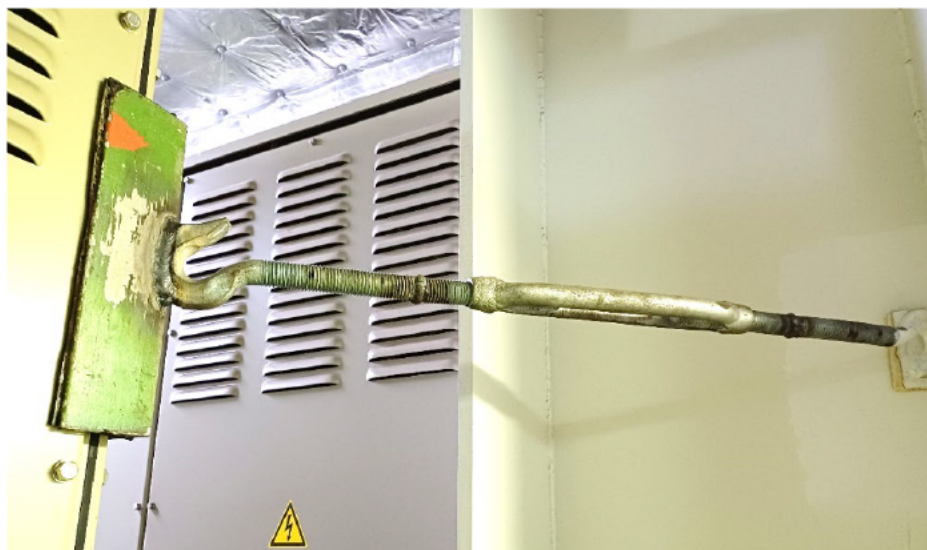
75. The DALI also had a vibration dampening rod wedged between the number 1 step-down transformer and a steel beam in the transformer room. It was jury-rigged, in the literal sense, from spare cargo equipment and painted white on one end. The anti-vibration rod is an after-market modification, not original to the build of the ship.

*Cargo chain turnbuckle, welded to angle iron, and wedged between the number 1 step-down transformer (left) and a steel beam (right).*

76. Problems obviously persisted after the rod's installation, since the steel bracket atop the number 1 step-down transformer cracked again.
